TEST KIT FERROXYL

Whether or not to pickle: the TEST KIT FERROXYL reveals embedded iron particles on stainless steel.

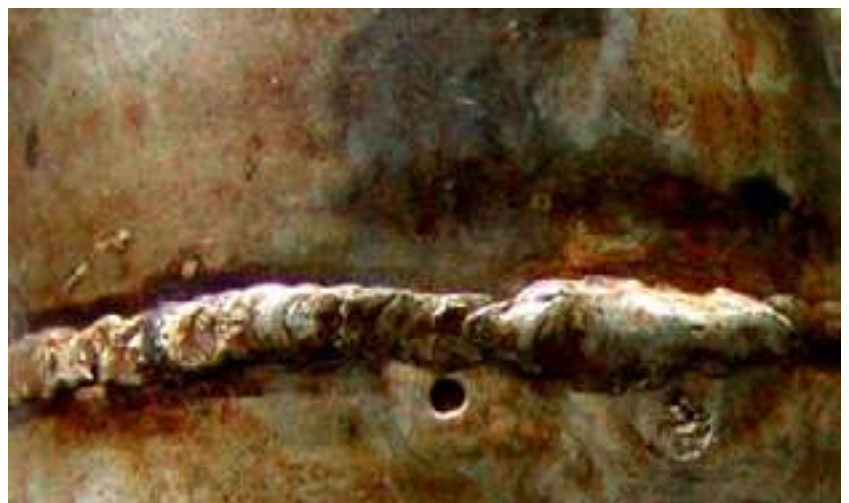
Example of pit corrosion caused by the presence of embedded iron

The presence of embedded iron in the stainless steel surface disturbs the chromium oxide film reducing the corrosion resistance locally. When embedded iron is not removed serious (pit) corrosion may set in.
